PINE CREEK DAM  
(North Park Lake)

NDI I.D. NO: PA-467

PHASE I INSPECTION REPORT  
NATIONAL DAM INSPECTION PROGRAM

MAY 1979

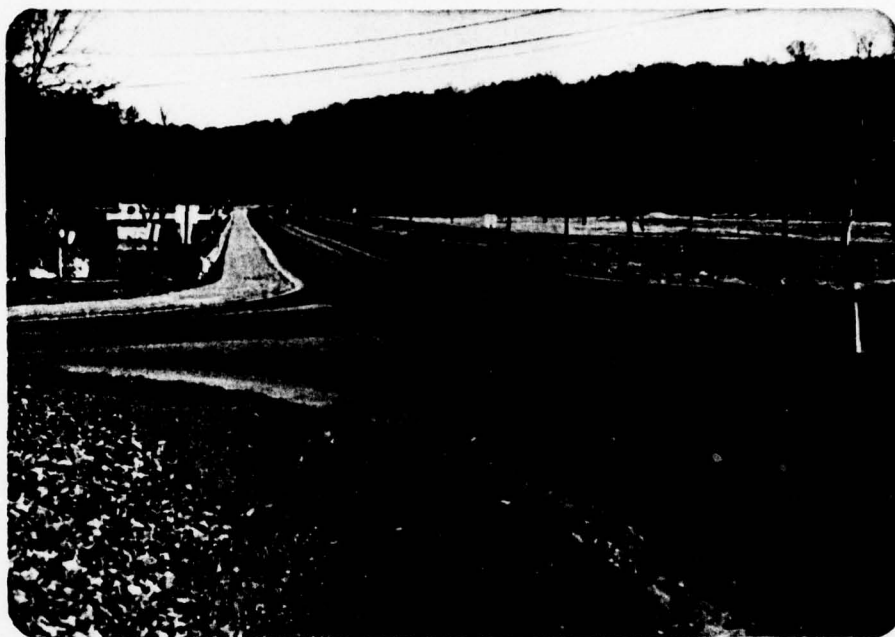
Photograph No. 1  
Crest (looking north).

In general, the condition of the dam was found to be good, with no signs of distress. The crest of the dam was found to be generally undulating, but with no signs of distress, such as settlement or surficial cracks. The fill material placed on the downstream side of the embankment gradually merges into the natural ground and no definable toe of the embankment exists. This area was searched for signs of seepage and none were found.

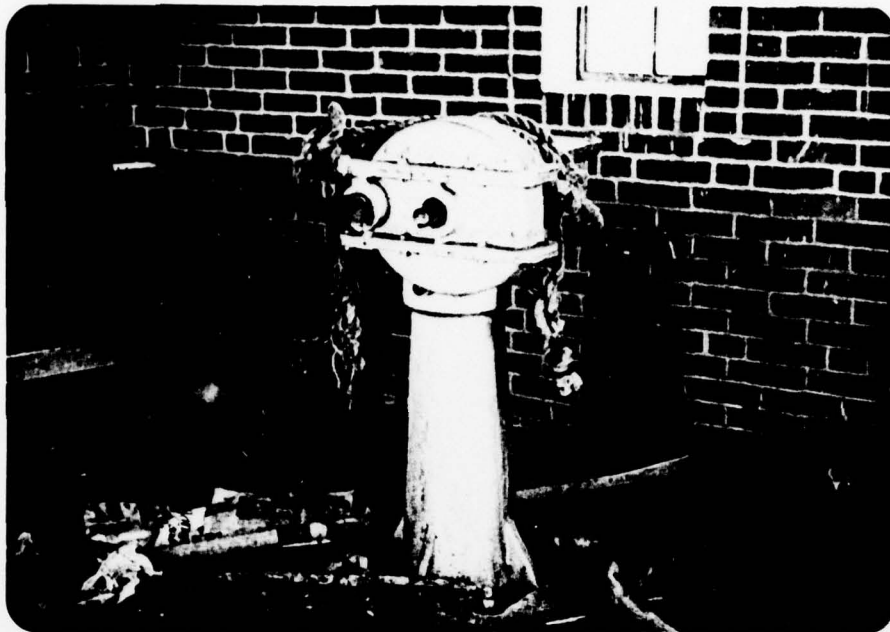
Photograph No. 5  
Outlet conduit sluice gate hoist.

It is reported that the outlet conduit sluice gate has not been operated in the recent past. Due to the siltation problem in the reservoir, the operational condition of the sluice gate was questionable; therefore, the operation of the sluice gate was not observed.

4.3 Maintenance of Operating Facilities. The maintenance of the operating facilities is considered to be poor. It is reported that the outlet conduit sluice gate has not been operated in the recent past. Due to the siltation problems in the reservoir, the operational condition of the sluice gate was questionable; therefore, operation of the gate was not observed.

It is reported that the outlet pipe gate has not been operated in the recent past. It is therefore recommended that the operational condition of the outlet pipe gate be evaluated and necessary maintenance performed.

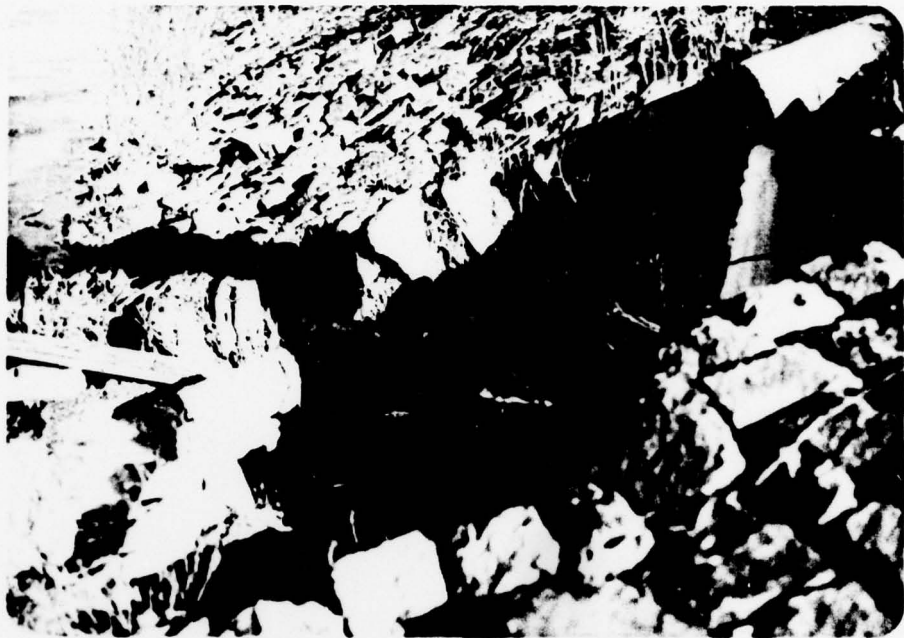
Photograph No. 7

4.2 Maintenance of the Dam. The maintenance of the dam is considered to be fair. The crest of the dam is covered with grass and appears to be periodically mowed. At several locations on the upstream face, the riprap was found to be missing. This riprap should be replaced to avoid erosion problems on the upstream face.

Erosion on upstream face riprap.

3. Missing riprap on the upstream slope should be replaced.
4. Brush should be removed from the upstream slope.
5. Spalling concrete in the spillway discharge channel should be repaired.
6. Around-the-clock surveillance should be provided during unusually heavy runoff and a formal warning system should be developed to alert downstream residents in the event of emergencies.
